# Materials Testing on the DC-X and DC-XA

Dane Smith, Carol Carroll, Jochen Marschall, and  
Joan Pallix

January 1997

National Aeronautics and  
Space Administration

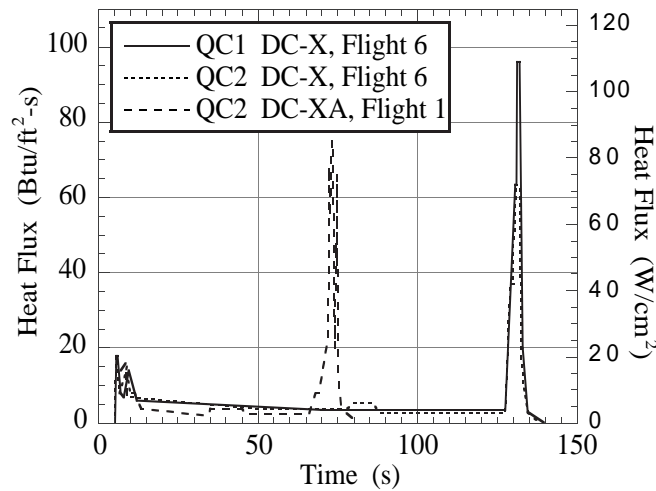
Figure 1(a). The approximations to the measured heat fluxes

TPS testing was carried out on DC-X flights 6, 7, and 8 (May 16, June 12, and July 7) in 1995. The most severe thermal environment occurred during vehicle landing. During landing the test panels were exposed to a short duration high temperature heat pulse (peak fluxes up to  $\sim 100 \text{ W/cm}^2$ ) and in most cases were simultaneously impacted by debris from the concrete landing pad. Representative heat flux measurements from calorimeters located in the DC-X and DC-XA base heatshields are shown in figure 1(a). This data was transmitted by Mike Johnson of MDA (Huntington Beach). The heat fluxes measured by calorimeter QC2 are considered the best representation of the heating environment seen by the test panel; see figure 1(b). The initial rise in heat flux corresponds to vehicle lift-off (at about 5 seconds) and the large spikes to vehicle landing. The DC-X flight 6 heating conditions are typical for landings on concrete, which were the case for most of the Delta Clipper flights. The heating conditions for DC-XA flight 1 are for a vehicle landing on a metal grate.

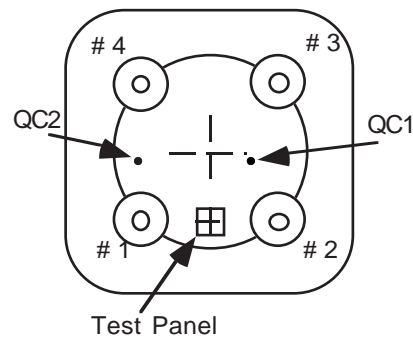
Figure 1(b). The locations of the two calorimeters relative to the test panel on the base of the DC-X and DC-XA.

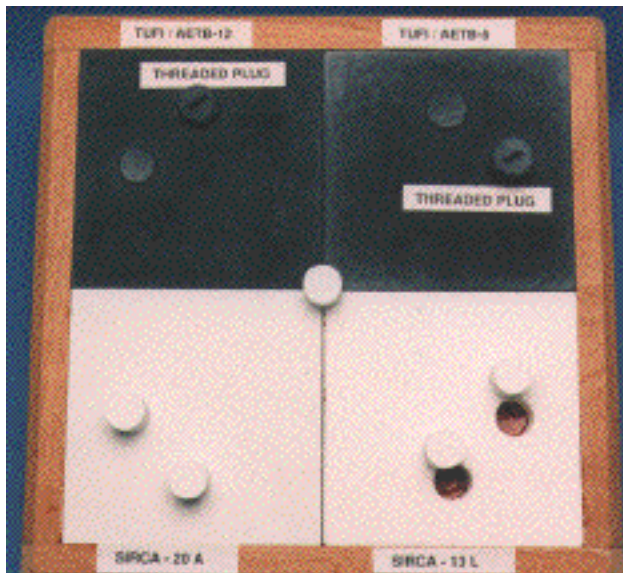
Figure 2(a). Pretest panel for DC-X flight 6. Contains different density TUF/AETB tiles (black) and SIRCA tiles (white). Note the nine plugs prepared to cover the attachment screws. Two of the plugs were machined out of TUF so that they could be screwed into place.

The TPS panel tested on flight 6 consisted of four 6 inch  $\times$  6 inch  $\times$  1 inch tiles of different densities. Two Toughened Unipiece Fibrous Insulation (TUF) tiles were prepared from 8 lb/ft<sup>3</sup> and 12 lb/ft<sup>3</sup> Alumina Enhanced Thermal Barrier (AETB) ceramic substrates, and are shown in figure 2. TUF tiles were developed specifically to be resistant to impacts. The white Silicone Impregnated Reusable Ceramic Ablator (SIRCA) tiles in the photo were prepared by silicone impregnation of 9 lb/ft<sup>3</sup> and 18 lb/ft<sup>3</sup> silica tile substrates.

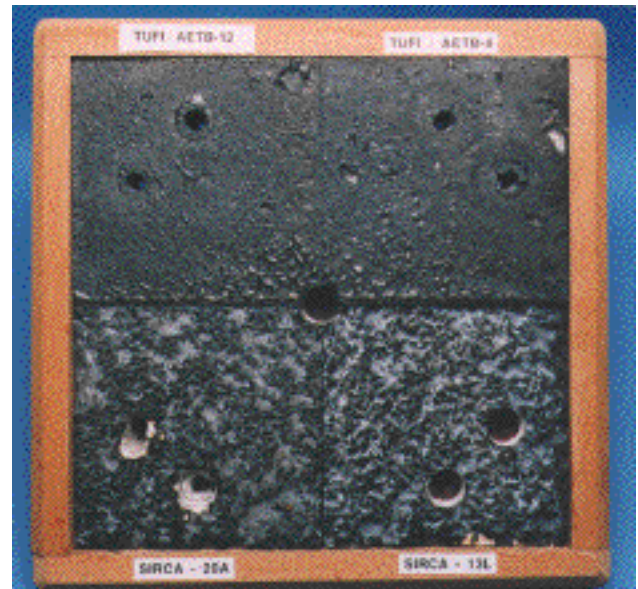
Figure 2(b). Posttest panel shows recession of SIRCA (about 1/4 inch). The plugs have been bored out to remove the panel from the vehicle. Note the textured glaze over the entire panel surface. This is presumably due to deposition of molten concrete. TUF/AETB-12 sustained the least impact damage.

Figure 2(b) shows the posttest panel. Posttest examination of the panel indicated that the TUF tiles were essentially unaffected by the high temperature experienced (primarily) during vehicle landing. Both TUF tiles, however, were pitted due to impact by pieces of solid and molten concrete which spalled from the landing pad. The 12 lb/ft<sup>3</sup> tile sustained much less damage than the 8 lb/ft<sup>3</sup> tile and was patched and reused in the next flight. The SIRCA tiles showed considerable erosion, recession, and some evidence of melting, from the combined thermal and impact environment. Modified versions of SIRCA

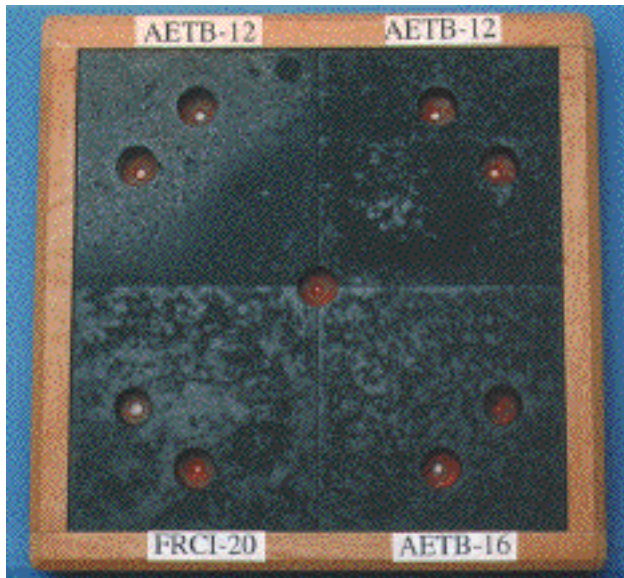
Figure 3(a). Pretest panel to be left on the vehicle for DC-X flights 7 and 8. Contains different densities of TUF/ AETB tiles and an FRCI-20 tile. The AETB-12 tile in the upper left corner was already flown on flight 6. FRCI tends to be more durable than AETB but doesn't withstand as high a temperature (ref. 3).

The other three tiles were replaced with new TUF tiles including a second TUF/ AETB-12, a TUF/ AETB-16 (16 lb/ft<sup>3</sup> tile) and a TUF/ FRCI-20 tile (20 lb/ft<sup>3</sup> tile; Fibrous Refractory Composite Insulation=FRCI). For this test, the performance of AETB and FRCI was compared. In general, AETB withstands a higher temperature than FRCI but FRCI is inherently stronger (ref. 3). This refurbished panel was left on the vehicle for flights 7 and 8. The pretest panel is shown in figure 3(a).

The panel shown in figure 3(a) was flown again on flight 8 with minor modifications. A technician was sent from Ames to repair several areas on the lower density tiles which had sustained impact damage during flight 7 and to demonstrate an on-vehicle repair process. Four 1/2 inch diameter damaged areas were bored out and plugs were inserted for repair (see fig. 3(b)). The entire repair process took only 15 minutes.

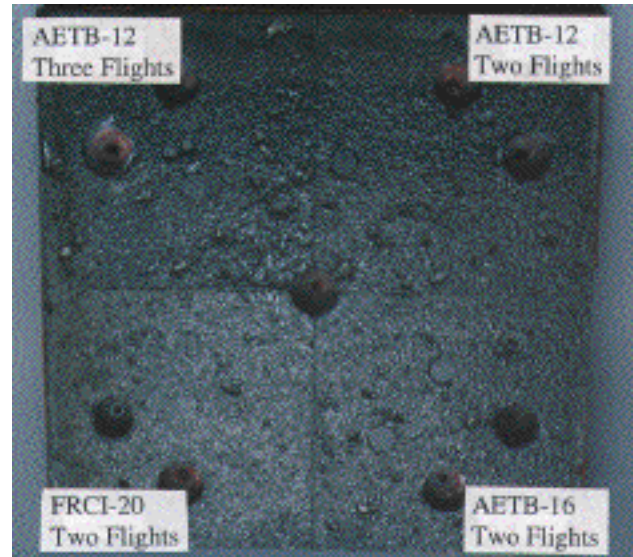
Figure 3(b). Posttest panel after flights 7 and 8. FRCI-20 shows the least impact damage as expected. Note the additional plugs that were installed between flights 7 and 8 in a quick on-vehicle repair.

Figure 3(b) shows the flight 8 posttest panel. Minimal additional impact damage was found on any of the TUFF tiles when compared with the previous flight. The actual landing of the DC-X took place much faster than in previous flights so the material exposure to extreme conditions was not as prolonged (i.e., on the order of 4 seconds as opposed to 7 seconds). Figure 3(b) clearly shows that the highest density tiles exhibit the least impact damage as one would expect.

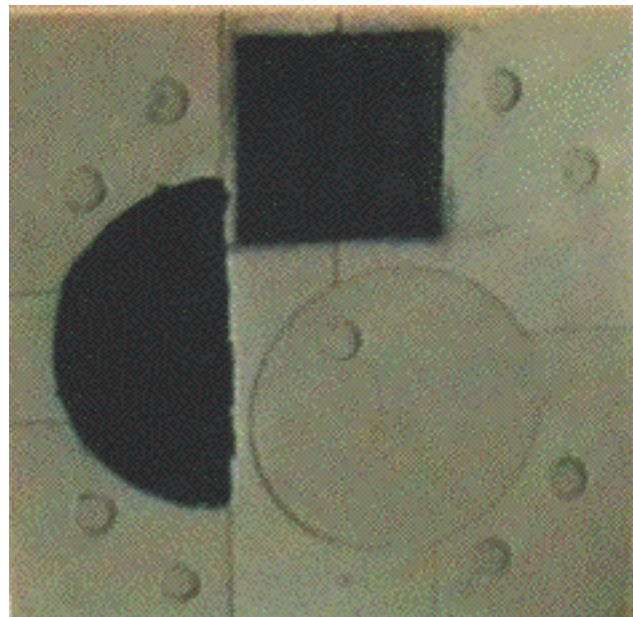
Figure 4(a). Second pretest panel for DC-X flight 7. Contains a variety of forms of SIRCA including a precharred sample (black half circle) which should have a more durable surface. A PCC coated CFBI blanket was also tested on this panel.

The panel shown in figure 4 was also flown on flight 7. This panel consisted of a 22 lb/ft<sup>3</sup> SIRCA tile (round white section), a 16 lb/ft<sup>3</sup> organic reusable coating application (ORCA) black semi-circle tile and a protective ceramic coating (PCC) coated SiC Composite Flexible Blanket Insulation (CFBI) black square. The SIRCA and ORCA performed well during this test. The surfaces became much more textured during the flight but there was no significant surface recession and no large

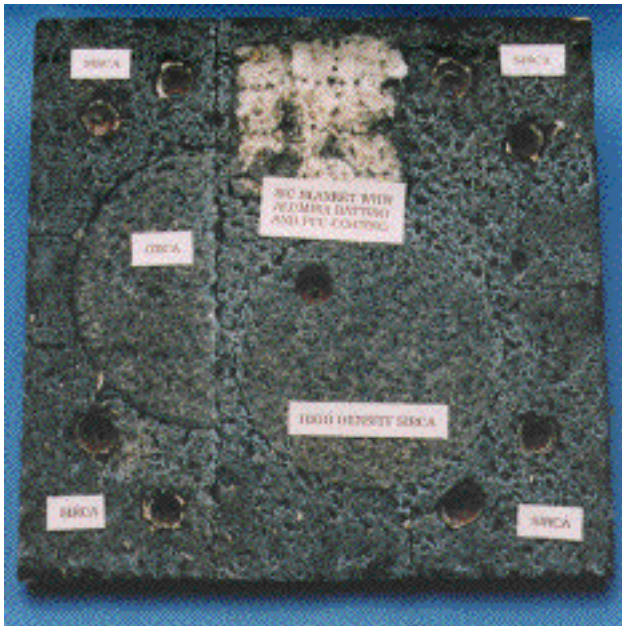
Figure 4(b). DC-X flight 7 posttest panel. The surface of the blanket is missing. The high density and precharred SIRCA performed the best. No surface recession was observed in any of the SIRCA samples but the surfaces became textured compared to the preflight specimens.

holes from molten concrete impact (see fig. 4(b)). The CFBI did not perform well and was so badly damaged that only the batting material remained. The mode of failure is not clear from this test. More work was done in 1996 to determine whether failure occurred due to heat flux, aerodynamic loads or impact damage (see discussion of DC-XA tests).

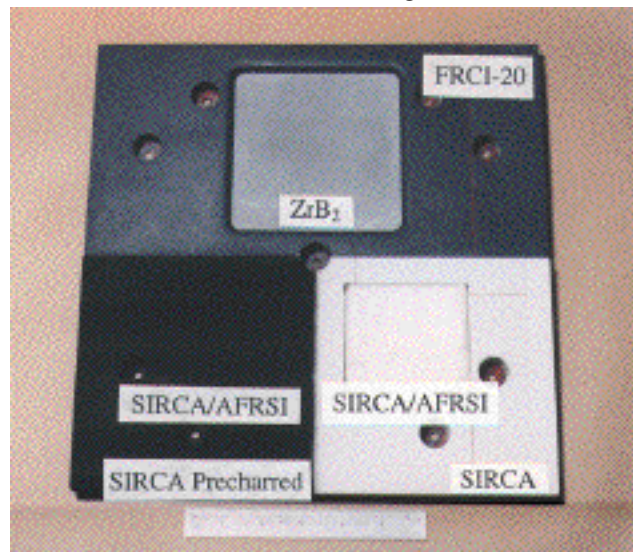
Figure 5(a). DC-XA flight 1 pretest panel. Contains TUF1/FRCI-20, a ZrB<sub>2</sub> composite, SIRCA tile and silicone impregnated AFRSI blankets with and without precharring.

As mentioned previously, a similar blanket did not survive the more extreme conditions of the base heatshield on flight 7 of the DC-X. On the first flight of the DC-XA a more durable blanket was tested on the base heatshield but still did not survive (fig. 5). In this case two

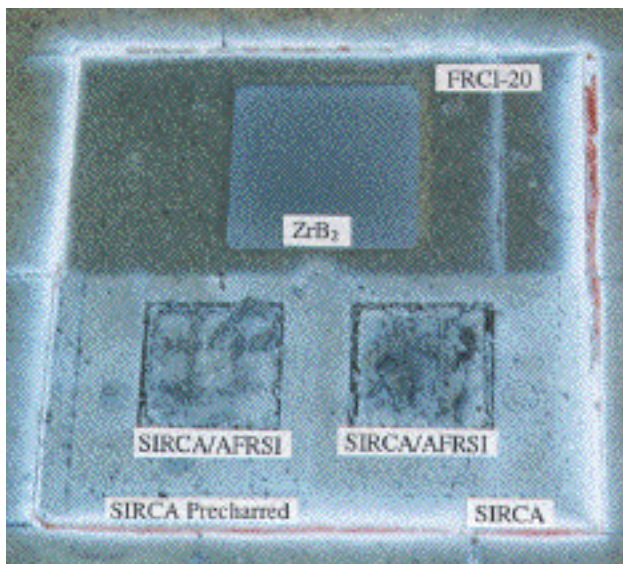
Figure 5(b). DC-XA flight 1 posttest panel. Note that no impact damage has occurred to any of the tiles yet the front fabric of the blankets is missing just as observed a flight 7 of the DC-X.

no impact damage was observed on the materials surrounding the blankets (see fig. 5(b)). Apparently the combined thermal and aerodynamic load experienced by the heat shield is too harsh for AFRSI. If a blanket surface undergoes severe deformation due to aerodynamic loads, the threads used to attach the batting to the fabric will break and the fabric can also tear. It is also likely that the temperature of loose surface fabric will rise sharply, since it has little intrinsic thermal mass and can no longer dissipate heat effectively by conduction to the underlying batting. This may also contribute to blanket failure.

The other materials tested on flight 1 included SIRCA-20, TUF1/FRCI-20 and a  $ZrB_2$  composite. As seen in figure 5(b), no significant damage occurred to any of these materials. However, there were tiny ( $\sim 0.5 \times 0.5 \times 0.5$  mm)

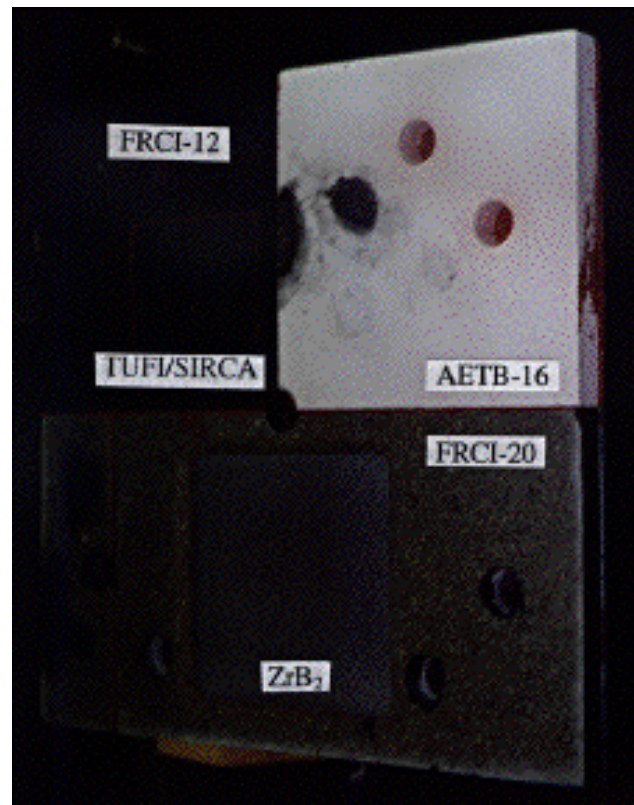
Figure 6(a). DC-XA flight 3 pretest panel. Bottom half of the panel is the one flown on flight 1. On top is a TUF1 tile that was impregnated with silicone to add durability. This 4 inch  $\times$  4 inch sample is surrounded by a TUF1/FRCI-12 tile. The upper right hand tile is an AETB-16 provided by MDTI. This tile was purposely damaged in the lab to test a quick repair method (see text).

On the top half of the panel shown in figure 6 there are three different materials including AETB-16 which was provided by MDTI, TUFI coated FRCI-12, and TUFI coated FRCI-20 that was impregnated with silicone. All three materials sustained some impact damage. The white areas around the attachment holes are damage resulting from the tools used to remove the panel after the flight. No photos are available prior to removal of the panel because there was no access to the vehicle during the accident investigation. However, it does appear that impact damage during landing was minimal on the higher density materials (AETB-16 and impregnated TUFI/FRCI-20) and more severe on the TUFI/FRCI-12.

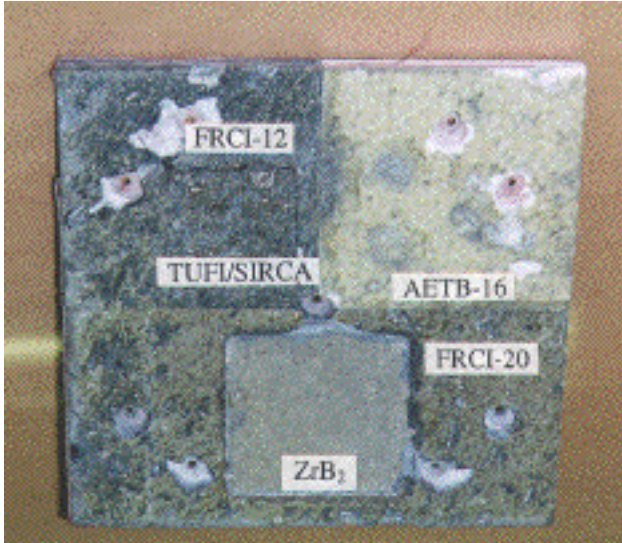
Figure 6(b). DC-XA flight 3 posttest panel. All materials survived and had a silica glaze deposited on the surface during landing on concrete. Note that the bright white areas are damaged due to panel removal from the vehicle and not due to flight damage.

The bottom half of the test panel contained the same TUFI and ZrB<sub>2</sub> specimens that were flown on the first flight. This time, the vehicle landed on concrete and the TUFI tile sustained moderate impact damage. The ZrB<sub>2</sub> composite, which is very dense (225 lb/ft<sup>3</sup>), was unaffected by the impact or thermal environment. This is the most resilient of the materials tested on any of the DC-X or DC-XA flights.

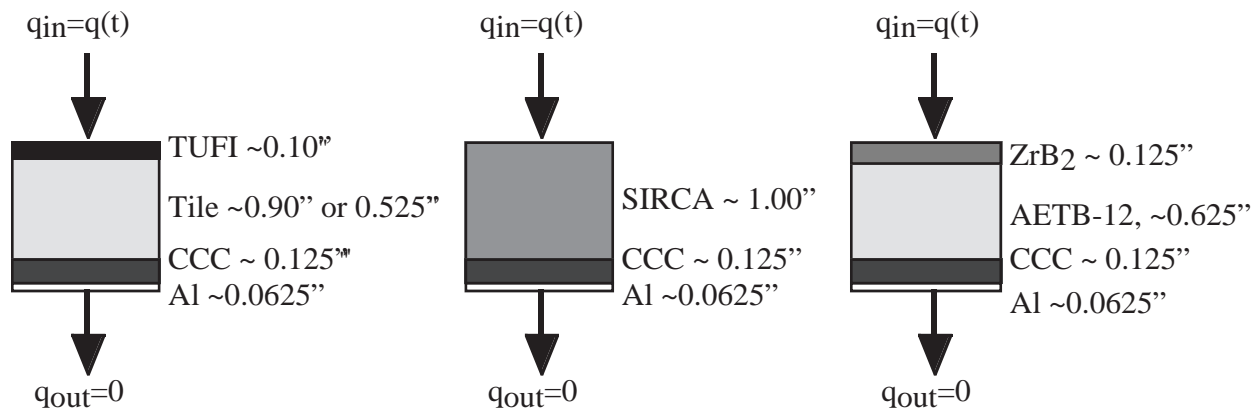
Figure 7. Schematics of the tile, SIRCA, and ZrB<sub>2</sub> panels analyzed.

Schematics of the material geometries analyzed are shown in figure 7. The materials involved are the reusable surface insulation (RSI) materials AETB-8, AETB-12,

and FRCI-20, the light weight ceramic ablators SIRCA-14 and SIRCA-18, and a diboride ceramic matrix composite. The tile panels consisted of 1 inch or 5/8 inch thick tiles bonded to a 1/8 inch thick carbon-carbon composite (CCC), which was mechanically attached to a 1/16 inch thick aluminum sheet. The AETB and FRCI tiles had a TUFU coating with a thickness was about 0.1 inch (out of the total tile thickness). In practice, an effective thickness was calculated from tile and TUFU densities such that the total added mass per unit area was equal to the manufacturing goal of  $0.17 \text{ g/cm}^2$ ; i.e.,

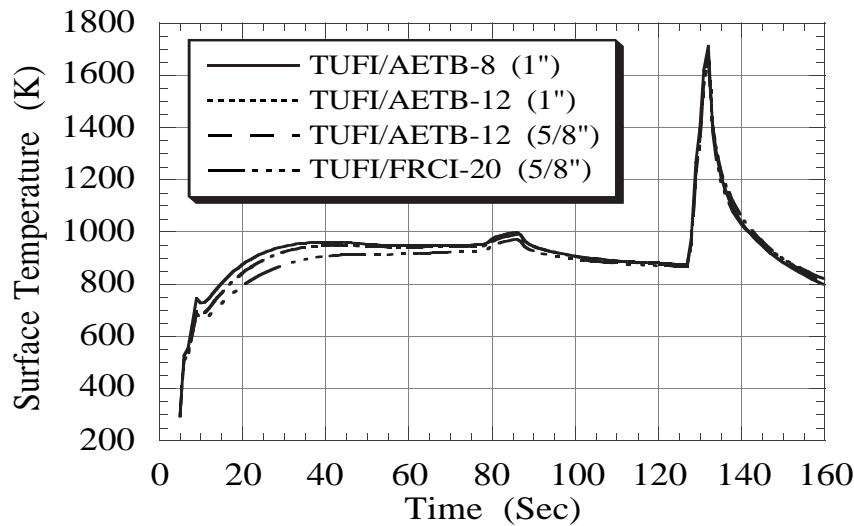
Figure 8. The temporal variation of the surface temperature for four RSI test panels exposed to the heat flux measured by calorimeter QC2 on DC-X flight 6.

The computed surface temperatures for the RSI tile test panels on flight 6 of the DC-X are shown in figure 8. The 1 inch and 5/8 inch thick tile specimens show the same surface temperature transients because both are sufficiently thick for very little heat to be drawn from the surface into the CCC and aluminum (over the time scale plotted). The maximum surface temperatures are reached during vehicle touchdown; about 1710 K for AETB-8 at 132 seconds. RSI materials are poor conductors of heat and their surface temperature response is driven by the need to reradiate most of the incoming heat flux. This response is modified in the present case by the thermal mass of the TUFU layer, which damps the rise in surface temperature somewhat. Generally, lower density tile

materials also have TUF1 coatings which are of lower density and which extend further into the material. As a consequence the surface temperature response is fastest on the AETB-8 tile and slowest on the FRCI-20 tile.

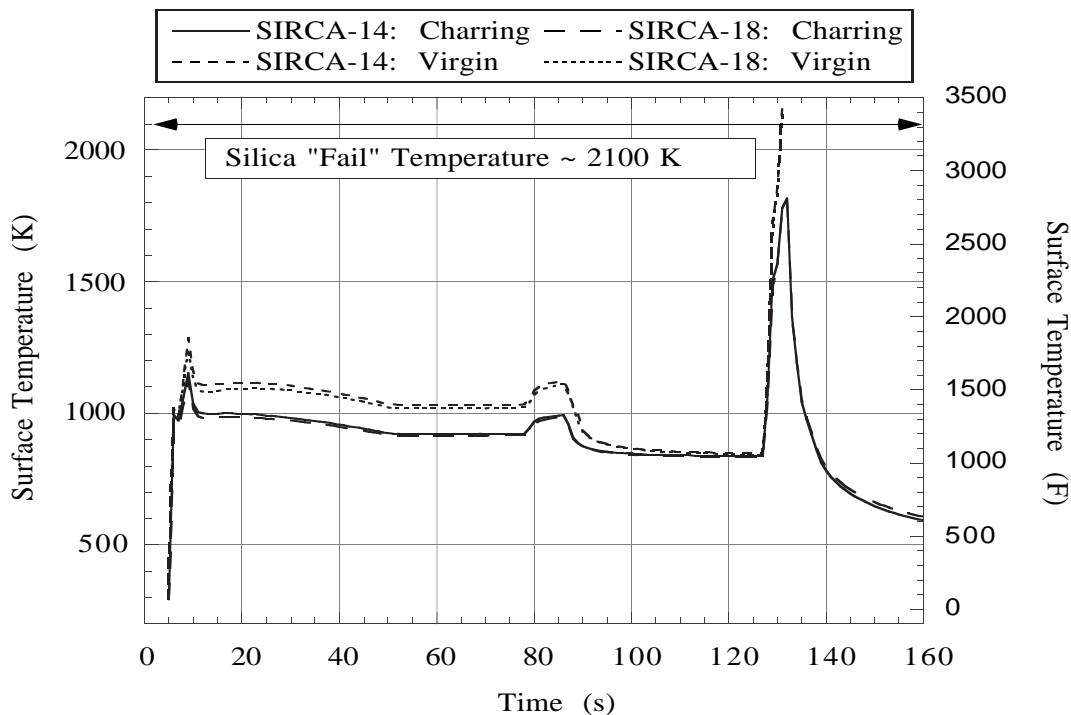
Figure 9. The temporal variation of the surface temperature for SIRCA-14 and SIRCA-18 test panels exposed to the heat flux measured by calorimeter QC2 on DC-X flight 6.

The calculated variation of surface temperature on the SIRCA test panels is plotted in figure 9. Again, because heat conduction away from the surface is minimal and surface temperatures are largely controlled by the reradiation of energy which depends on the surface emittance, the temperature variations for SIRCA-14 and SIRCA-18 are almost identical. The surface temperature response to changes in input heat flux is much quicker for SIRCA than for the RSI tile materials because the damping provided by the TUF1 layer is not present. The temperature dependent emittance of virgin and fully charred SIRCA has been estimated in reference 5 from room temperature reflectance measurements. The emissivity of the charred material is relatively insensitive to temperature, with values of about 0.95. The emissivity of the virgin material varies greatly, dropping from a room temperature value of about 0.92 to about 0.58 at 1000 K and 0.33 at 2000 K. (These high temperature values for virgin SIRCA assume no char formation at elevated temperatures.) The silicone resin which impregnates SIRCA's silica tile substrate pyrolyzes over a

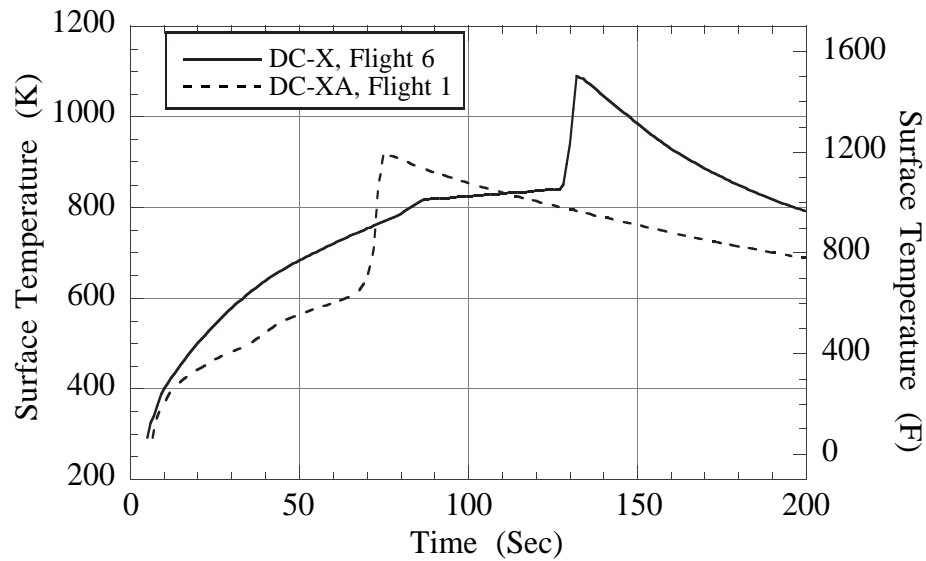
Figure 10. The computed surface temperature of the  $\text{ZrB}_2$  specimen for the QC2 calorimeter heat fluxes measured on DC-X flight 6 and DC-XA flight 1.

Figure 10 shows surface temperature profiles computed for the  $\text{ZrB}_2$  specimen using the heat fluxes measured by calorimeter QC2 on DC-XA flight 1 and DC-X flight 6. (This specimen was only flown on DC-XA flights 1 and 3, however DC-X flight 6 heat fluxes are typical of all landings on concrete and should be representative of conditions experienced on DC-XA flight 3.) The maximum surface temperature reached on the  $\text{ZrB}_2$  specimen for the DC-X flight 6 heat flux is about 1100 K. This is hundreds of degrees lower than the temperatures reached by the tile and SIRCA specimens for the same conditions. It is also clear from figure 10 that the temperature response to heat flux variations is much slower than for the tile and the SIRCA samples. Both of

these effects are a direct result of the large thermal mass and relatively high conductivity of the  $\text{ZrB}_2$  test specimen. This combination allows the specimen to absorb a large quantity of energy and heat up almost uniformly, with a resulting damped rise in surface temperature.

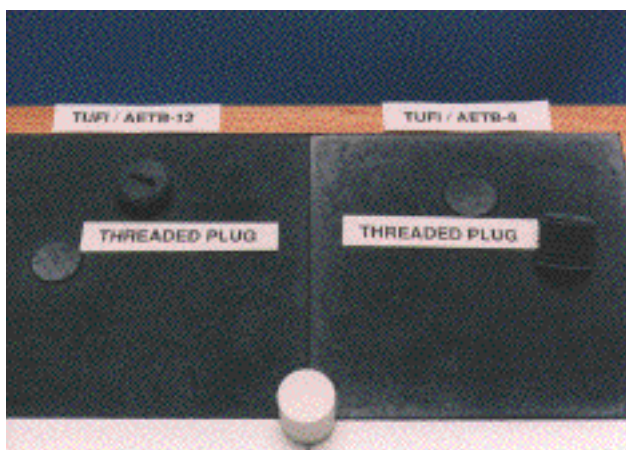
Figure 11. Screws machined from TUF.

Plugs were fabricated to provide the required protection for the panel attachment screws shown in most of the photos. These were glued in after the composite plate was attached to the vehicle. After testing, the plugs were typically destroyed using a screwdriver to remove the attachment screws. For the first DC-X flight test panel, threaded plugs with a slotted surface (fig. 11) were fabricated for the TUF panels to demonstrate the machineability of TUF and to provide reusable plugs which would not require adhesive. During landing, a layer of glass was deposited in an irregular pattern on the TPS surface (fig. 2(b)). This thin glass coating sealed the threaded plugs so that it was necessary to bore them out to remove the panel. The threads inside the holes remained intact so that new threaded plugs could be inserted when necessary.

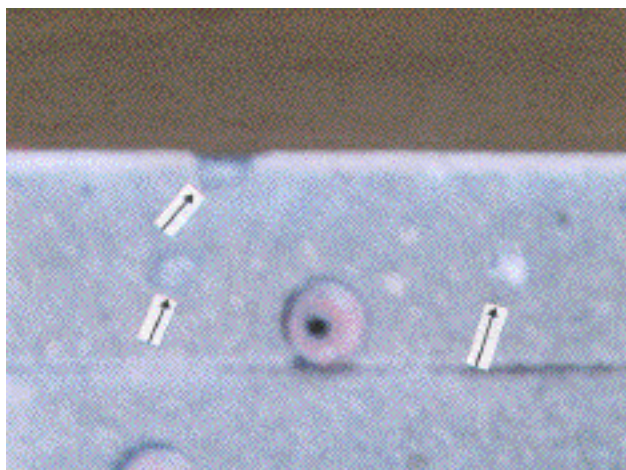
Figure 12(a). Ames fabricated FRCI-20 showing damage in three areas.

Figure 12 shows the FRCI-20 tile damaged, repaired preflight and repaired postflight. The damage to the FRCI-20 occurred during the first flight of the DC-XA. Damage consisted of two holes approximately 0.5 inches in diameter and 0.25 inches deep. There was also one chipped edge approximately 0.5 inches across and 0.25 inches deep (fig. 12(a)). The damage was repaired using a quickfix containing a high emissivity agent. The repaired tile damage (three black areas) is shown in figure 12(b). After applying the quickfix, a 24-hour drying period was allowed and the patch was as hard as the TUF. Postflight inspection shows that the patched areas on the surface of

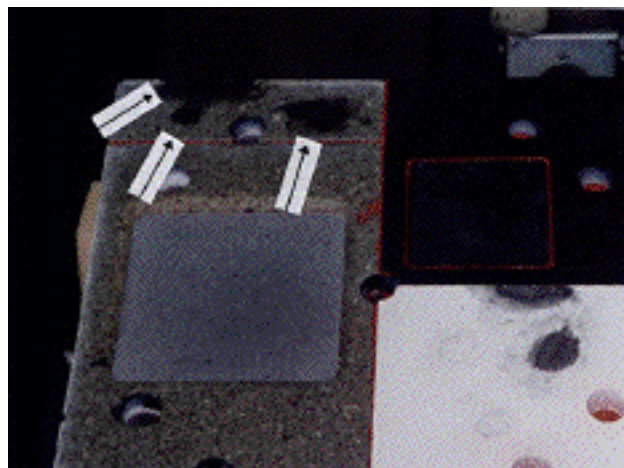
Figure 12(b). FRCI-20 showing repairs using quickfix putty.

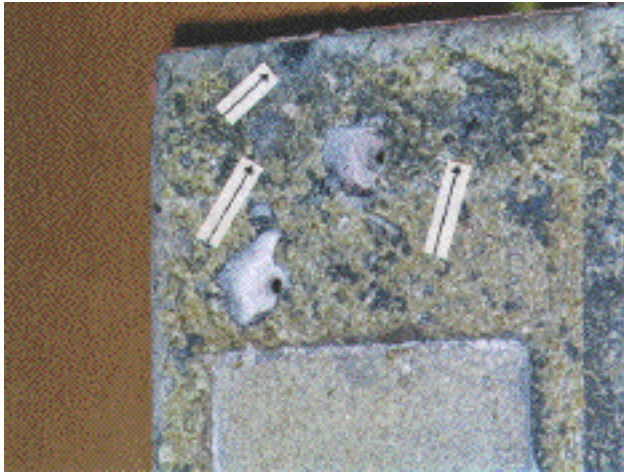
Figure 12(c). FRCI-20 posttest. Quickfix adheres well.

the FRCI-20 remained intact while the patch on the edge shows some shrinkage (fig. 12(c)).

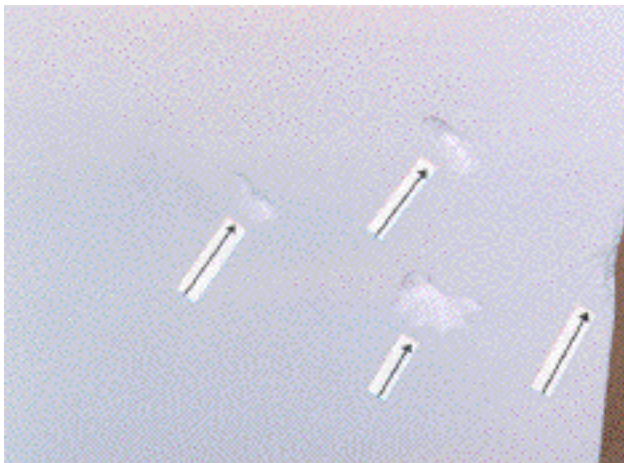
Figure 13(a). AETB-16 provided by MDTI showing damage created with a screwdriver.

The AETB-16 tile was supplied with a high density coating which raised the density to 38 lb/ft<sup>3</sup>. The damage areas shown in figure 13(a) were made with a screwdriver just to demonstrate the repair process. There are four damaged areas including two on the surface that are approximately 0.75 inches long and 0.5 inches across and 0.25 inches deep. Another larger area on the surface is about 1 inch in diameter and 0.5 inches deep. The fourth damaged area is along the edge of the tile and is the largest at about 2 inches long and 0.5 inches deep. Figure 13(b) shows that the damaged edge and the large hole were repaired using black quickfix and the two smaller holes were repaired using a white quickfix.

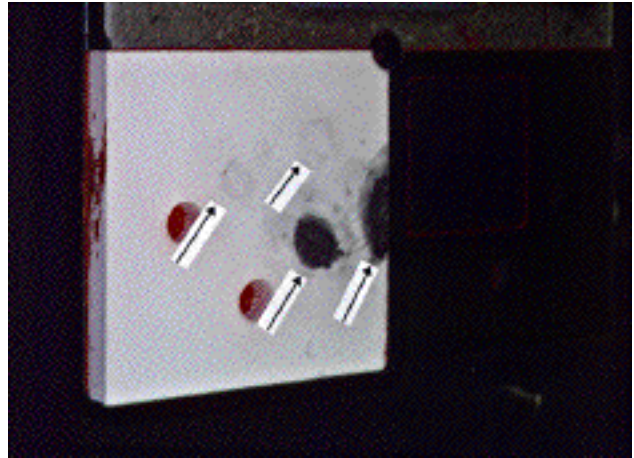
Figure 13(b). MDTI-AETB-16 showing preflight repair using quickfix with and without high emissivity agents.

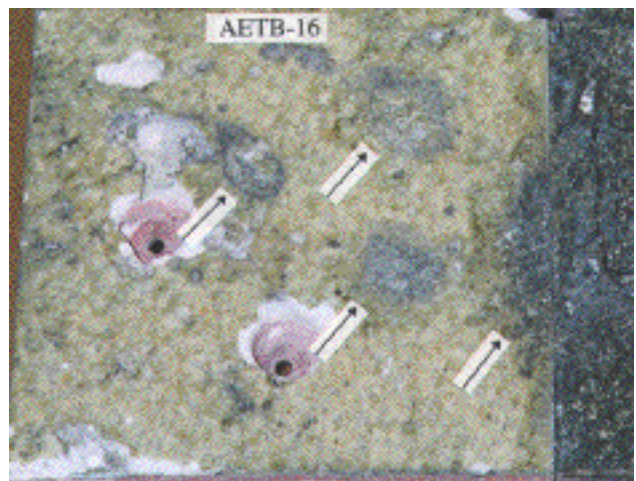
Figure 13(c). MDTI AETB-16 posttest. Shows excellent adherence of quickfix and no severe impact damage to repair areas compared to other areas of the tile.

repaired areas was no worse than on other areas of the tile. Note that the white damage areas seen in figure 13(c) occurred during removal of the tile from the vehicle.
